SPEED MECHANICS

RAMBLER

continued

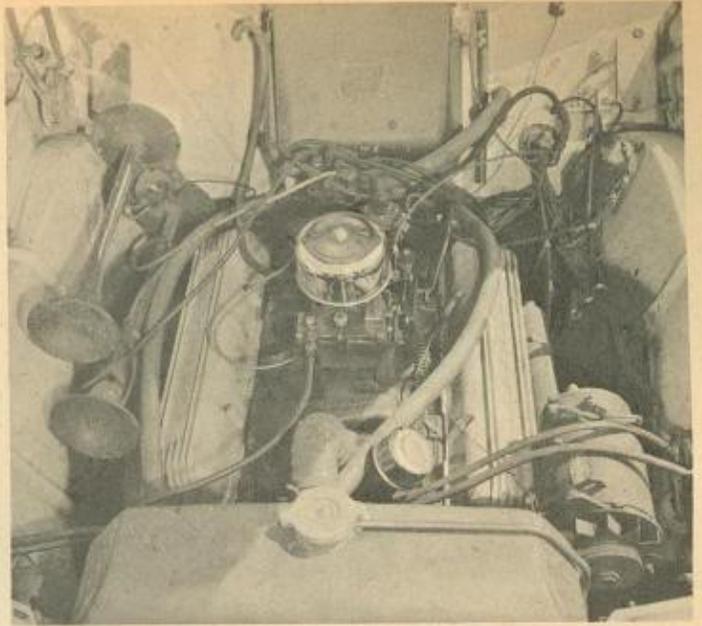
The main pain of the swap is only hinted here: Plugs are almost impossible to reach. Rambler radiator was fitted with larger upper tank; battery was moved. Quad carb has been installed since photo was taken.

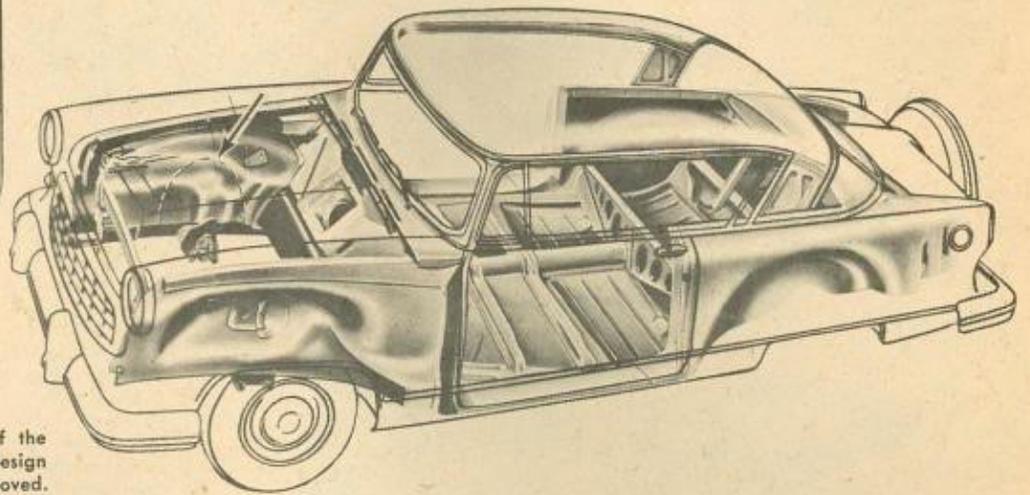
Above: Cross-section through the center of the controversial cut shows the double-wall design and (at dotted line) section that was removed. Because great strength is derived from shape of the section removed, merely substituting heavier gauge metal (shaped to clear the engine) is not a perfect solution. Right: Broken line indicates area of metal removed from inner panel.

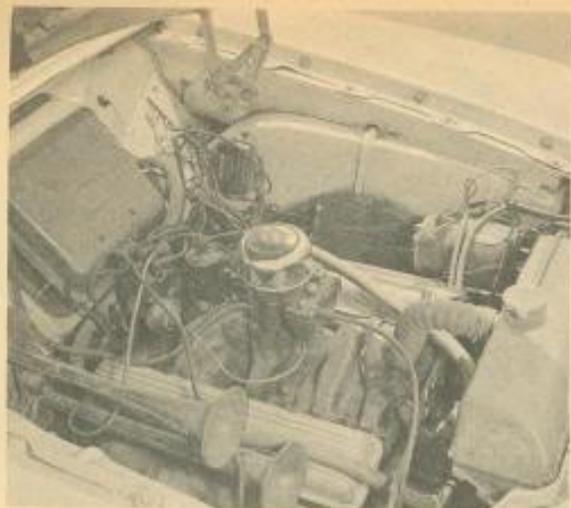
Metalsurgery to left inner wheelhouse panel is apparent. No attempt was made to restore strength lost in this operation. Main stress load is now concentrated in the outer section of car's wheelhouse panels.

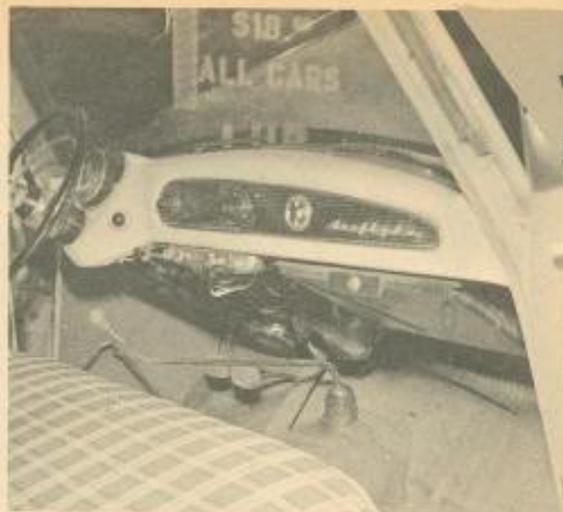
The only interior indication of the conversion is a floor-shift lever which operates a '48 Ford pickup gearbox. Note that a section was cut from the heater shroud to clear the lever when in reverse or second.

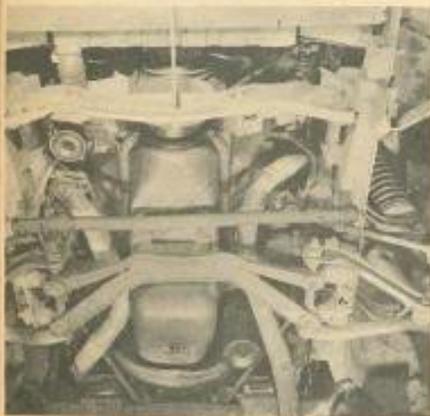
Some slight denting of the Chev oil pan was necessary to clear Rambler steering linkage. K-brace between suspension arms is stock.

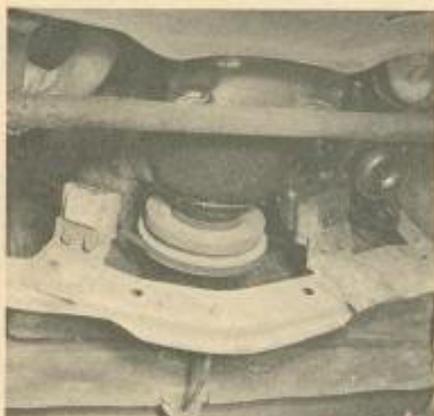
Front engine mounts were made from wide angle iron and welded to back of Rambler front crossmember to support stock motor pads on the Chevy. No guessing was used.

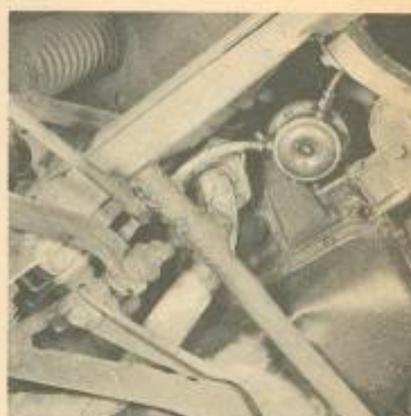
A '55 Chevy manifold is fitted on right bank and a '57 manifold on left. Routing of gas line could be improved upon.

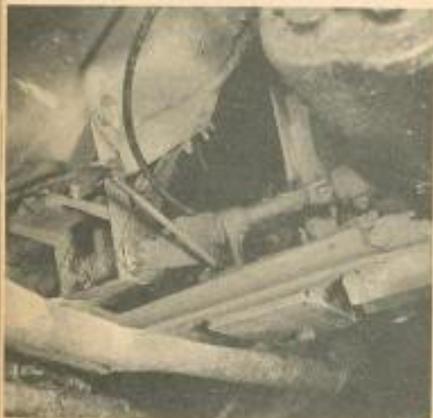
Clutch linkage is a combination of Rambler and Ford. Rear crossmember was beefed-up to handle the weight of the Ford pickup trans.

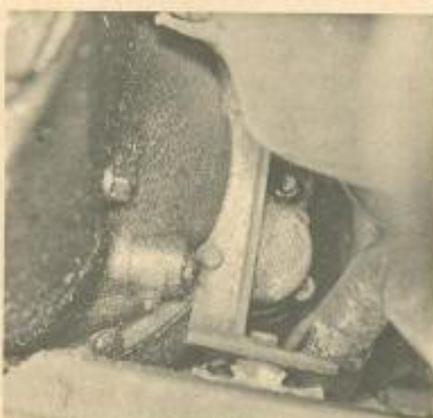
Rear mounts consist of angle iron, shaped to fit and bolted to bellhousing (right-side shown), which are welded to flat stock which rides on Ford truck pads.

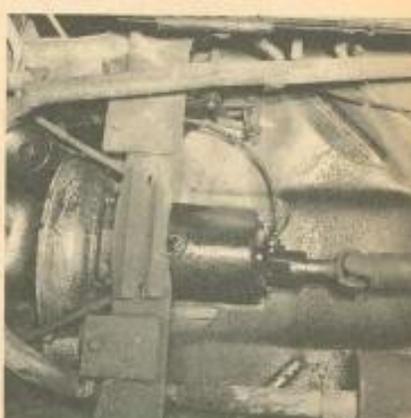
Trans change made driveshaft a bit too short causing yoke to ride about 1 1/2-in. too far back on the tallshaft splines.
